**SURFACE CHEMICAL METHODS OF  
DISPLACING WATER AND/OR  
OILS AND SALVAGING FLOODED EQUIPMENT**

**PART 2 - FIELD EXPERIENCE IN RECOVERING  
EQUIPMENT DAMAGED BY FIRE ABOARD  
USS CONSTELLATION AND EQUIPMENT  
SUBJECTED TO SALT-SPRAY ACCEPTANCE TEST**

September 19, 1961

**U. S. NAVAL RESEARCH LABORATORY  
Washington, D.C.**

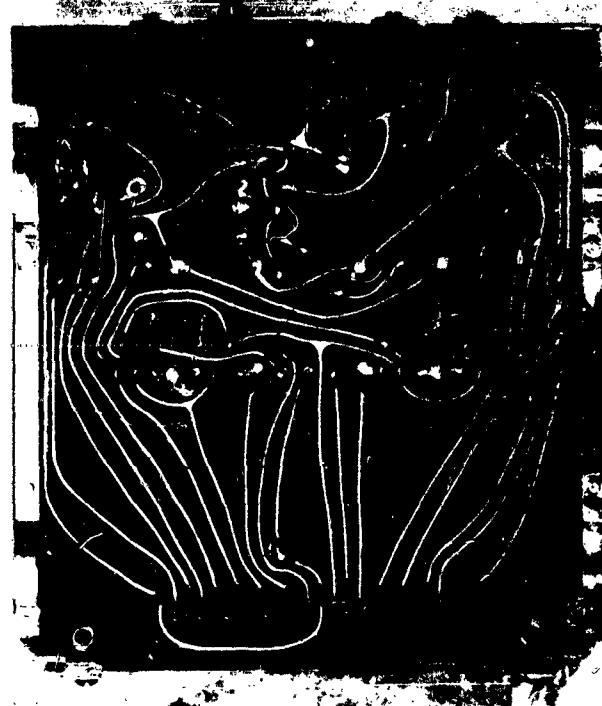
(a) - Appearance before cleaning

(b) - Appearance after cleaning

Fig. 5 - AMCS (Aero 1A Radar) printed circuit damaged by salt spray

Personnel assisting in the reconditioning work noted that the ultrasonic exposure was remarkably effective in removing salt corrosion products from aluminum and brass surfaces. Although no oily contamination was present the emulsion cleaner was still essential because of its ability to loosen and suspend such corrosion products. However, a much lower proportion (10 percent) of the concentrate in water was sufficient in the absence of oil and grease. The results of the recovery procedure are illustrated in Figs. 4 and 5.
